CERCLA Integrated Site Assessment

**Illinois Environmental
Protection Agency**

SOUTHERN CALIFORNIA CHEMICAL CO.

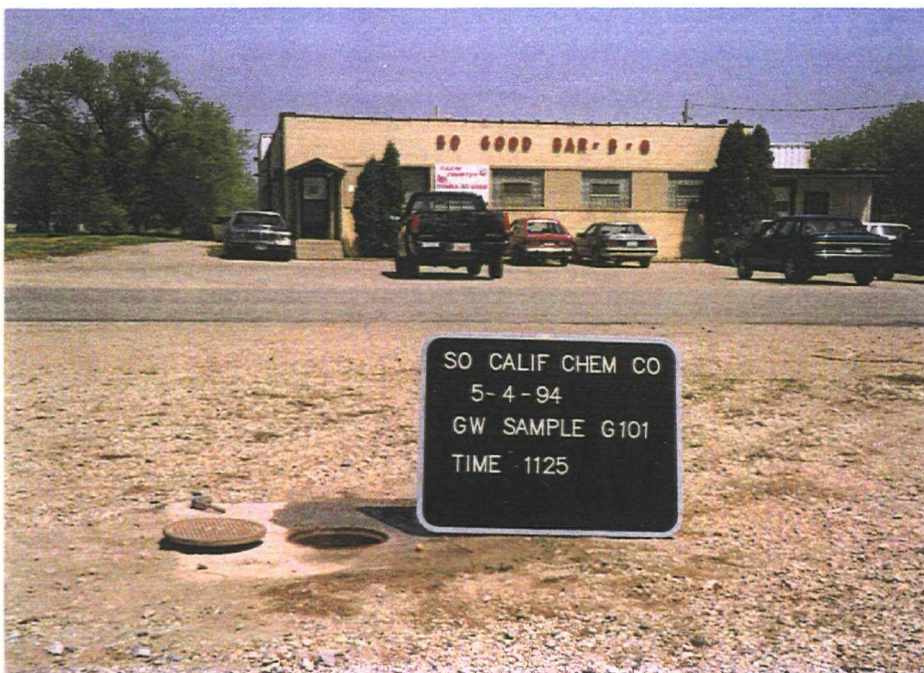
PICTURE TAKEN TOWARD
the north.

Photo taken at sample point G101. The SO GOOD BAR B QUE Company in the background is an active business and lies across Jefferson Street.

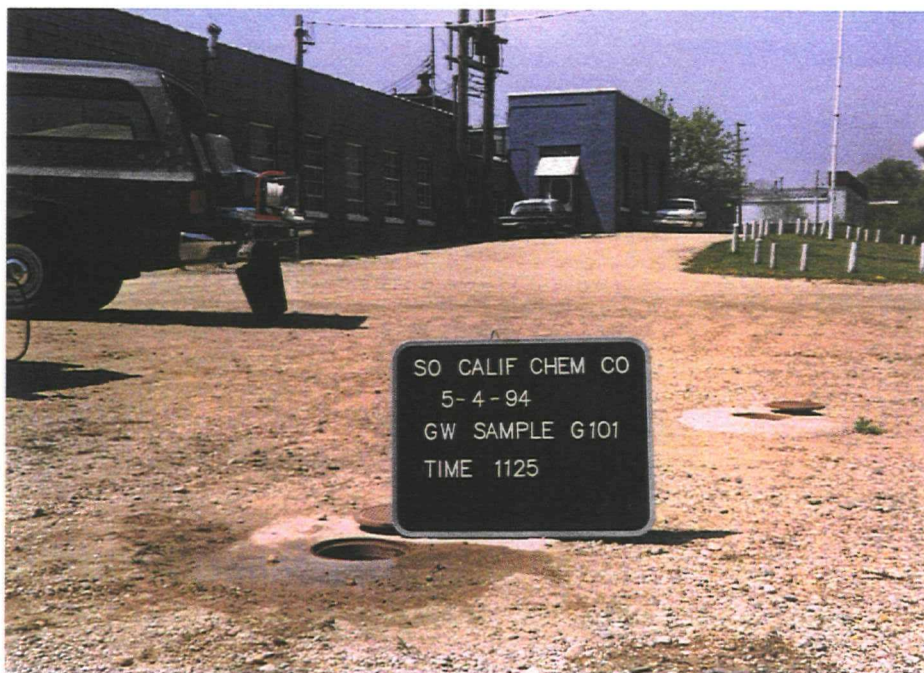
PICTURE TAKEN TOWARD
the west.

Manufacturing building of So. California Chemical Co. is to the upper left. The well to the right is a piezometer and was not sampled. Jefferson Street is to the right of the photo.

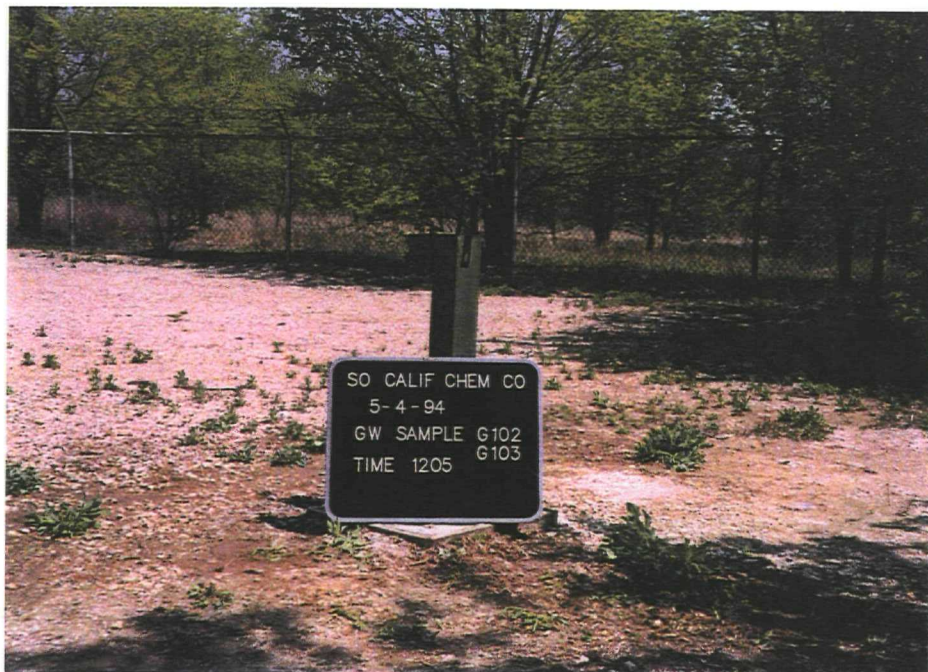
PICTURE TAKEN TOWARD
the east.

The dump area lies beyond
the fence. The CNW RR
tracks are to the right
of the photo.

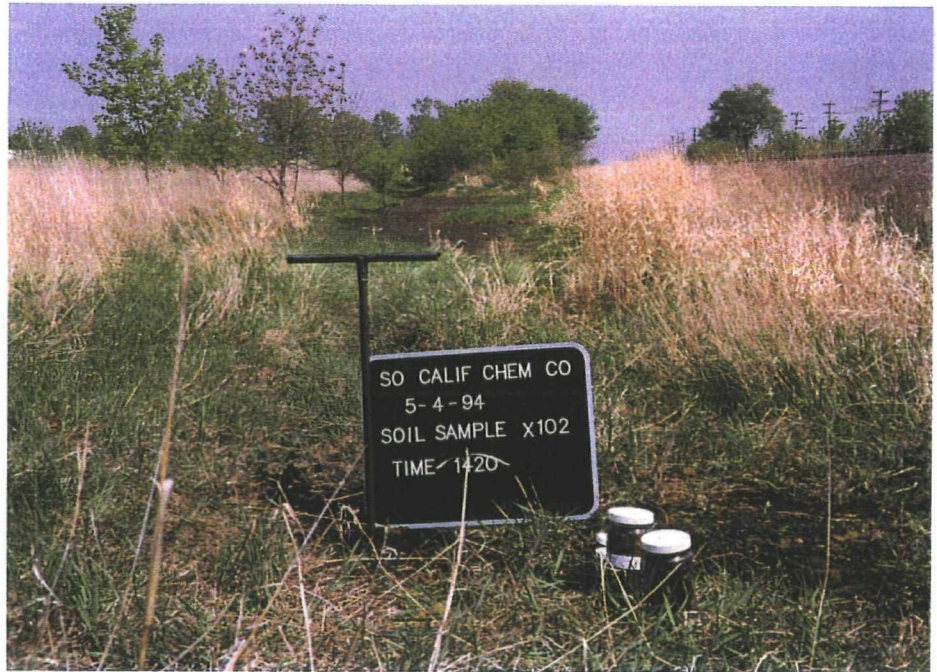
PICTURE TAKEN TOWARD
the east.

Sample X102 was collected
in a drainage pathway
along the CNW Railroad
tracks, which can be seen
in the upper right corner
of the photo.

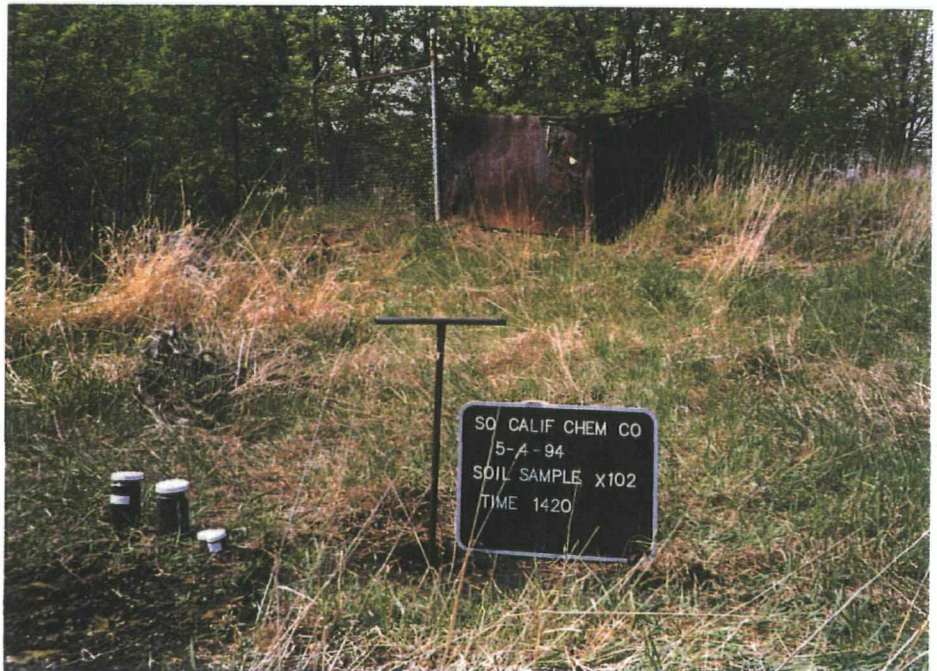
PICTURE TAKEN TOWARD
the northwest.

Sample X102 was collected
at a depth of 2 to 3 feet.
The southeast corner of
the fence of So. Calif.
Chem. Co. is left of the
rusted object. The dump
area is to the right.

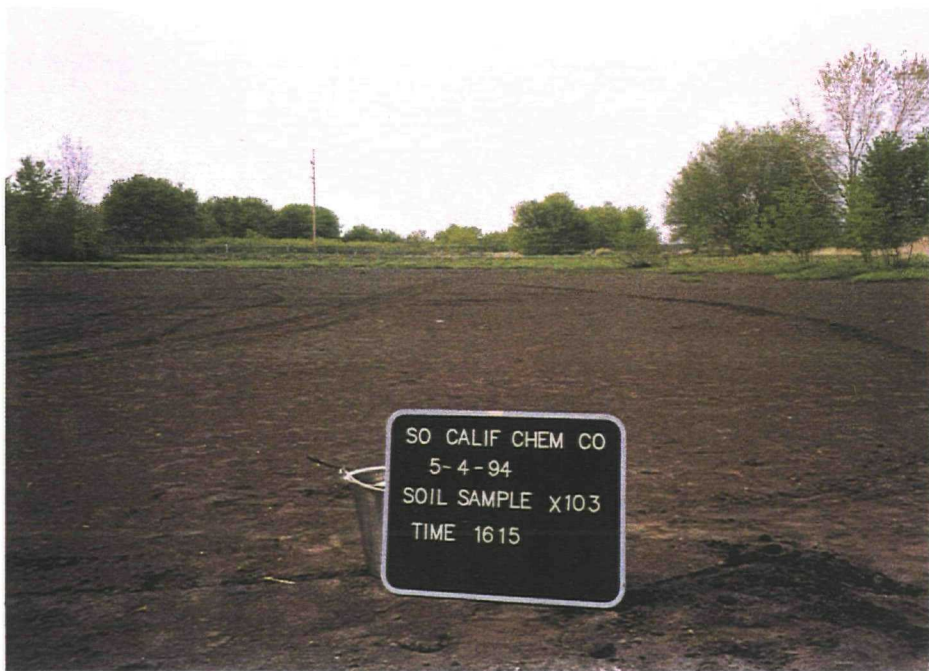
PICTURE TAKEN TOWARD
the north.

Sample X104 and duplicate
sample X105 were collected
at this location and
inadvertently listed as
X103 on the photo board.
The sample was obtained
in a low area in the
southeast section of the
dump area. Note RV tracks.

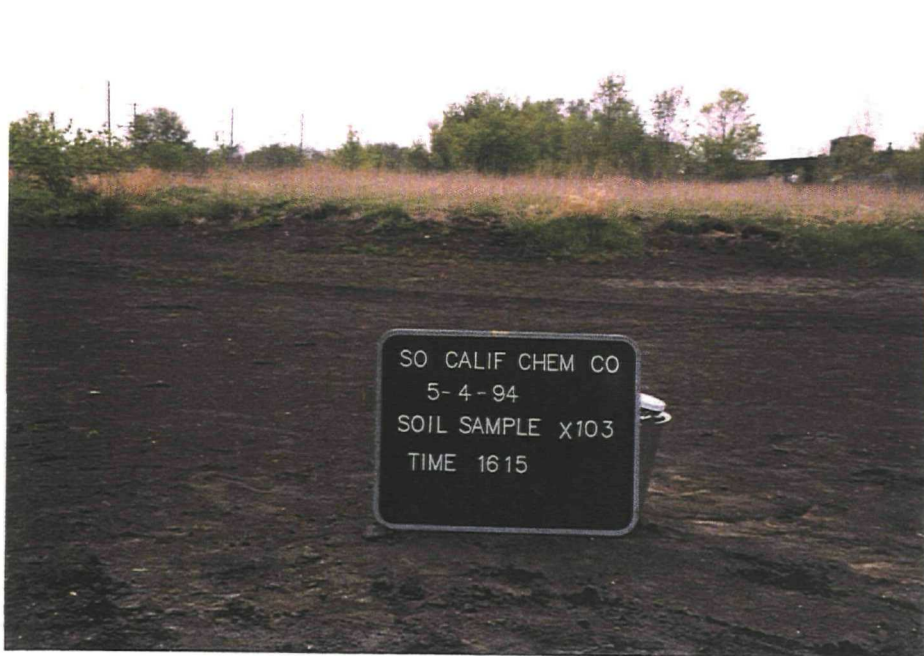
PICTURE TAKEN TOWARD
the west.

Sample point X104/X105
mistakenly labeled as
X103 on the photo board.
Sample was obtained at a
depth of 2 to 3 feet in
an area that contains
standing water during
various times of the year.

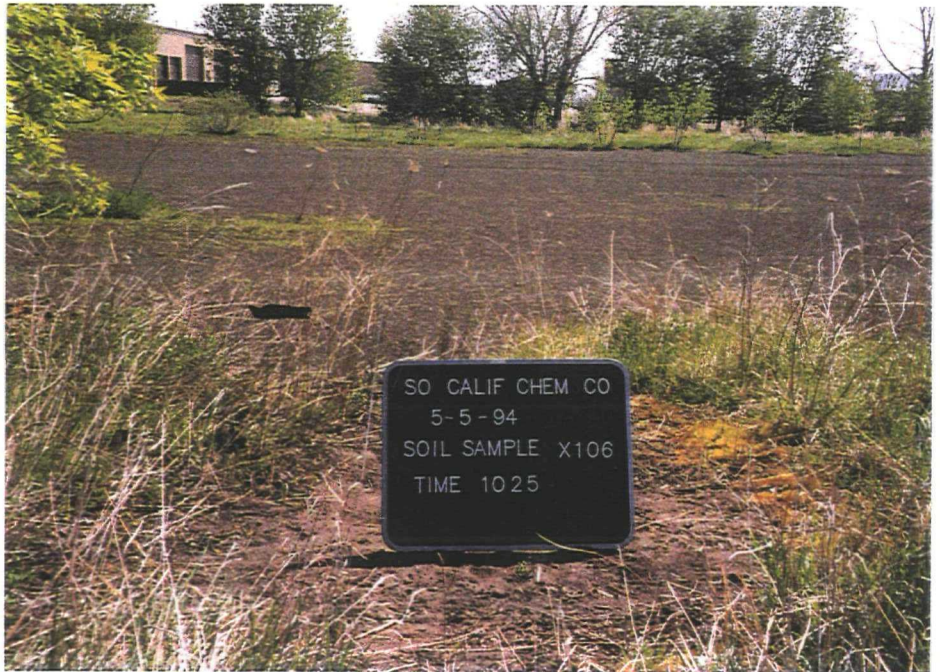
PICTURE TAKEN TOWARD
the east.

Sample collected in the
central portion of the
dump area on high ground
near the boundary with
the lower ground. Sample
collected at a depth of 2
to 3 feet.

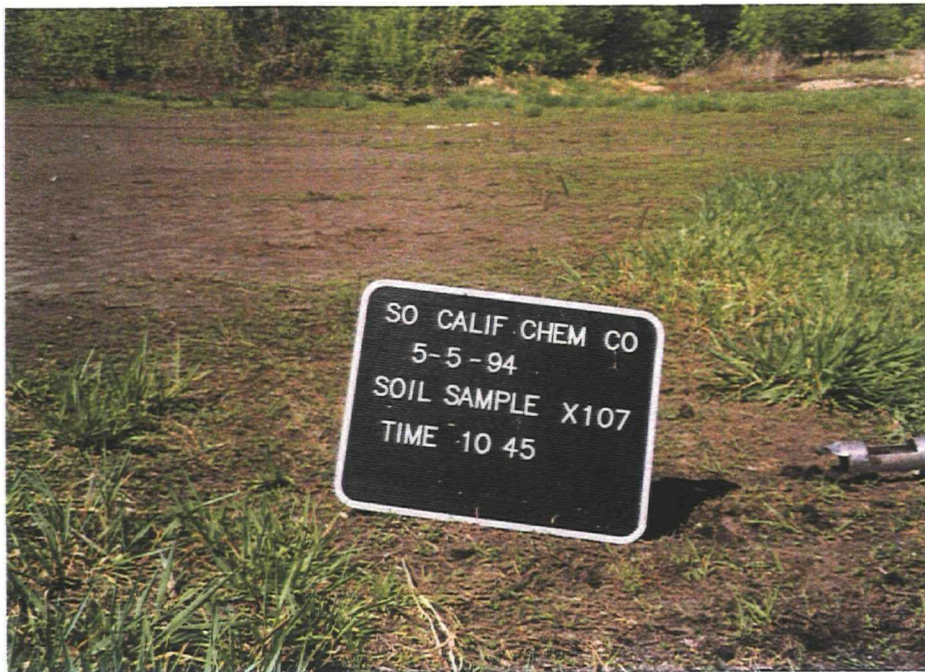
PICTURE TAKEN TOWARD
the west.

Sample X107 collected at
the northeast section of
the dump area at a depth
of 2 to 3 feet.

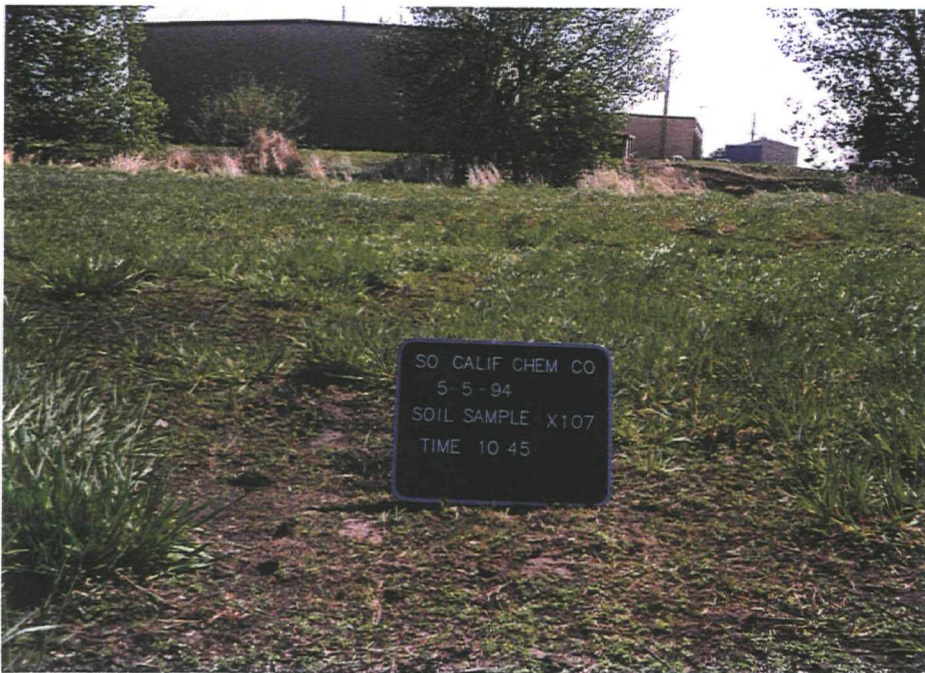
PICTURE TAKEN TOWARD
the east.

Sample X107. Property
ends at the treeline at
the top of the photo.

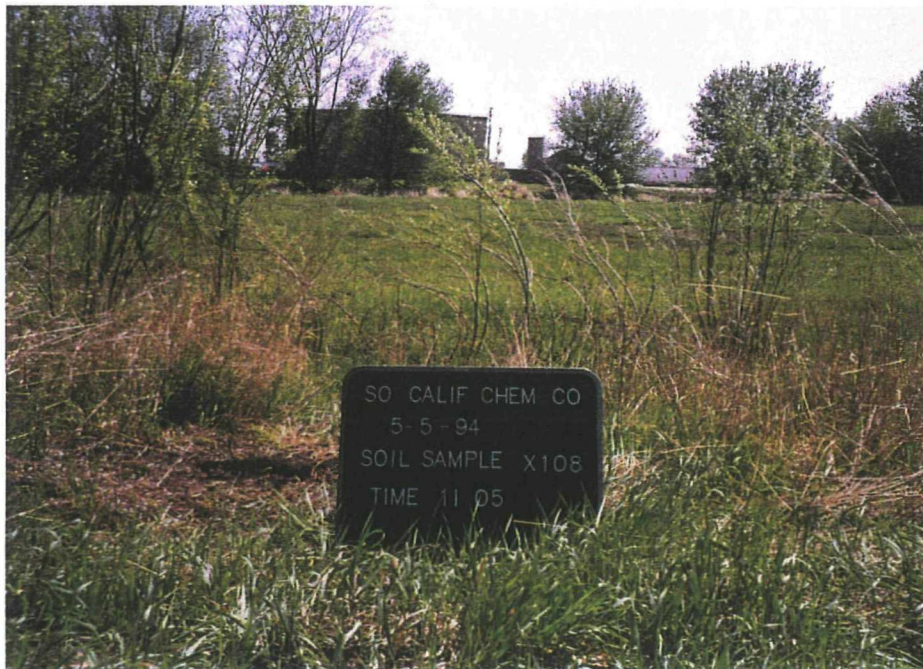
PICTURE TAKEN TOWARD
the east.

Sample X108 in the north-
west portion of the dump
area on the high ground
side. The sample was
collected at a depth of
2.5 to 3.5 feet.

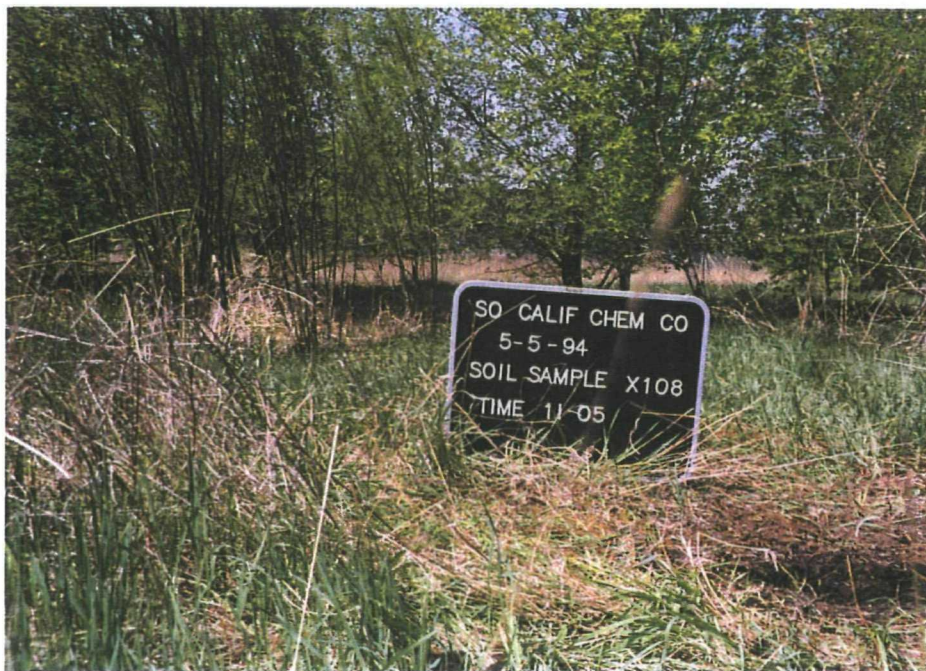
PICTURE TAKEN TOWARD
the west.

Sample X108. The fence
separating the dump area
and the So. Calif. Chem.
Co. property is approxi-
mately 95 feet beyond the
photoboard.

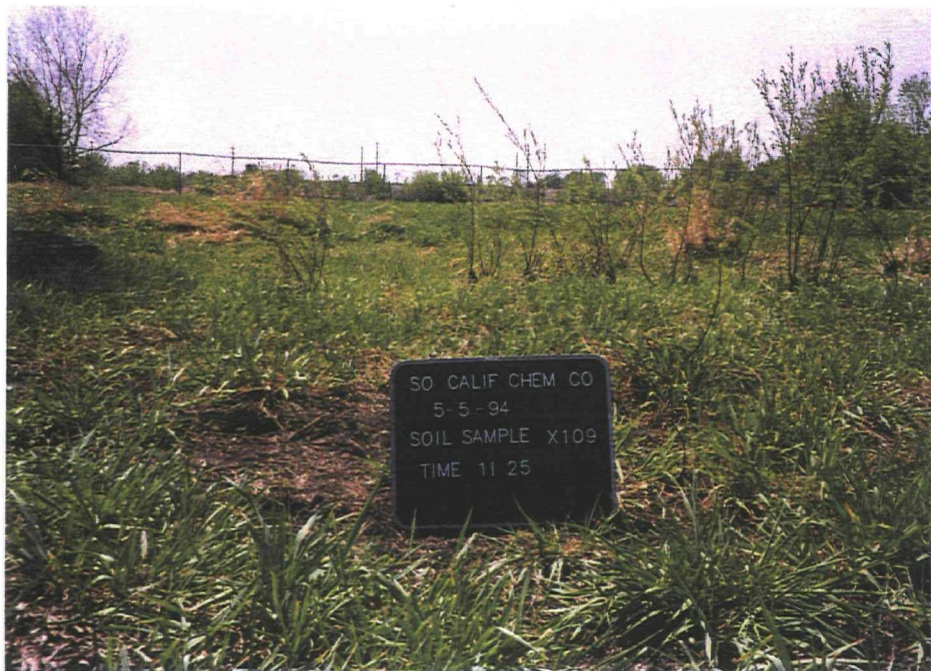
PICTURE TAKEN TOWARD
the south.

Sample X109 was collected
from a wetland north of
the dump area across
Jefferson Street at a
depth of 6 to 12 inches.
Beyond the fence in the
background is the dump
area.

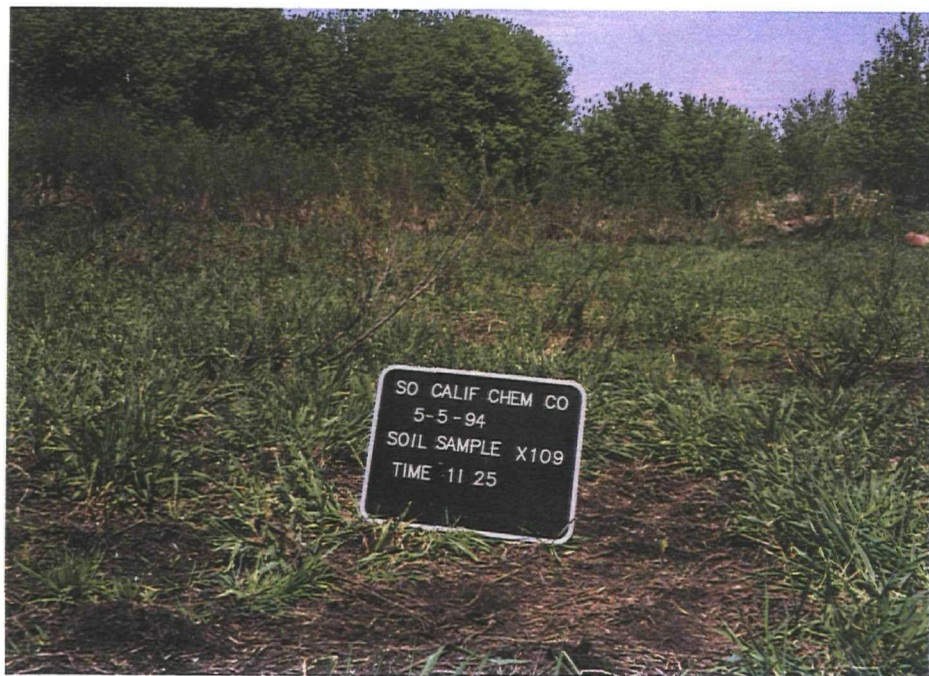
PICTURE TAKEN TOWARD
the northwest.

Sample X109.

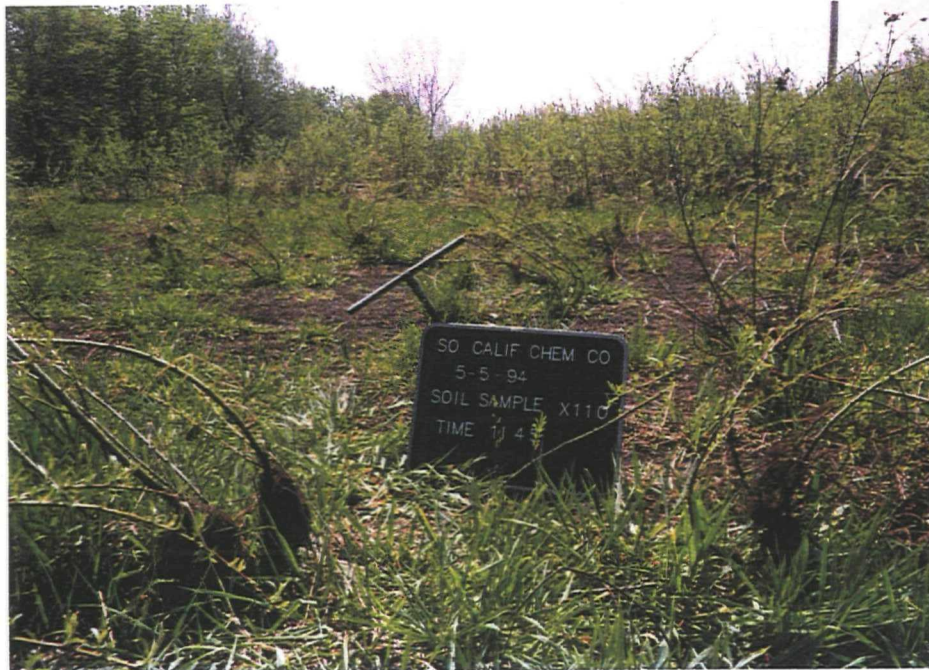
PICTURE TAKEN TOWARD
the south.

Sample X110 collected
from the northern portion
of the wetland located
north of the dump area.
Sample was collected at a
depth of 6 to 12 inches.

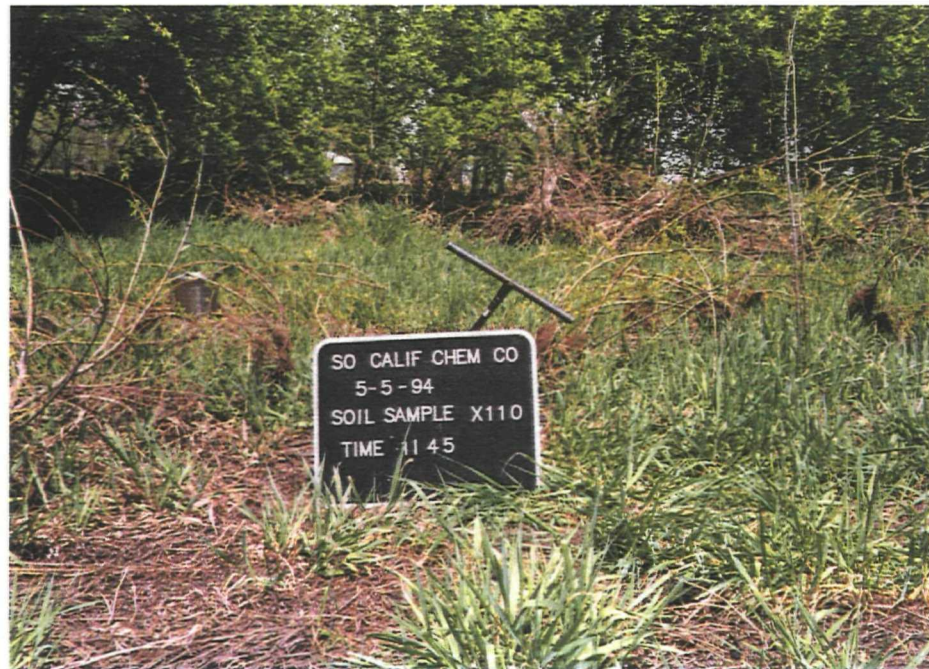
PICTURE TAKEN TOWARD
the north.

Sample X110. The So Good
Bar B Que company is
located left of the photo.

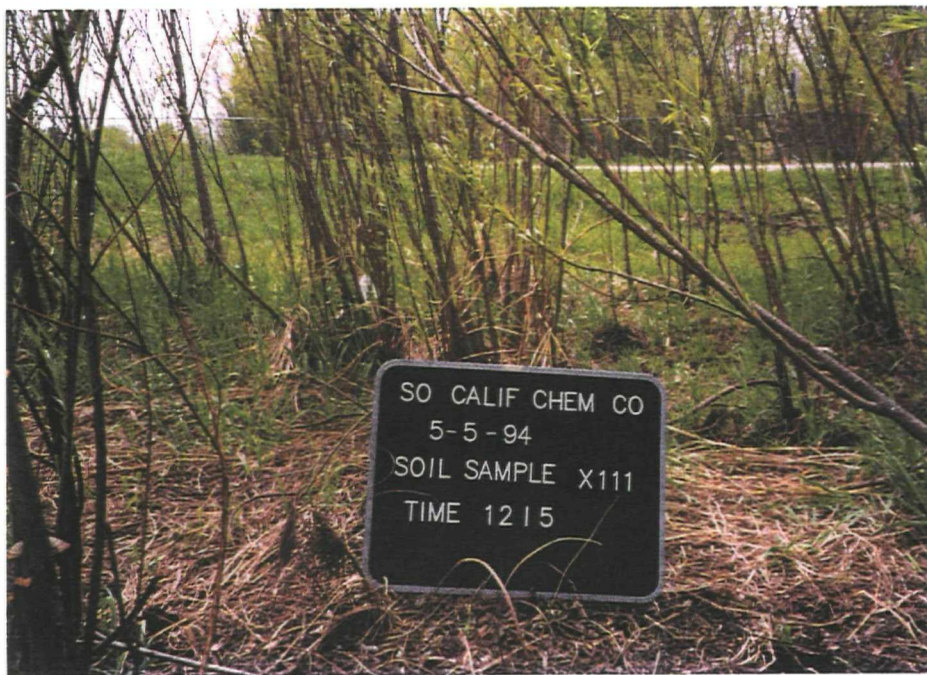
PICTURE TAKEN TOWARD
the south.

Sample X111. Jefferson
Street is visible in the
upper portion of the
photo.

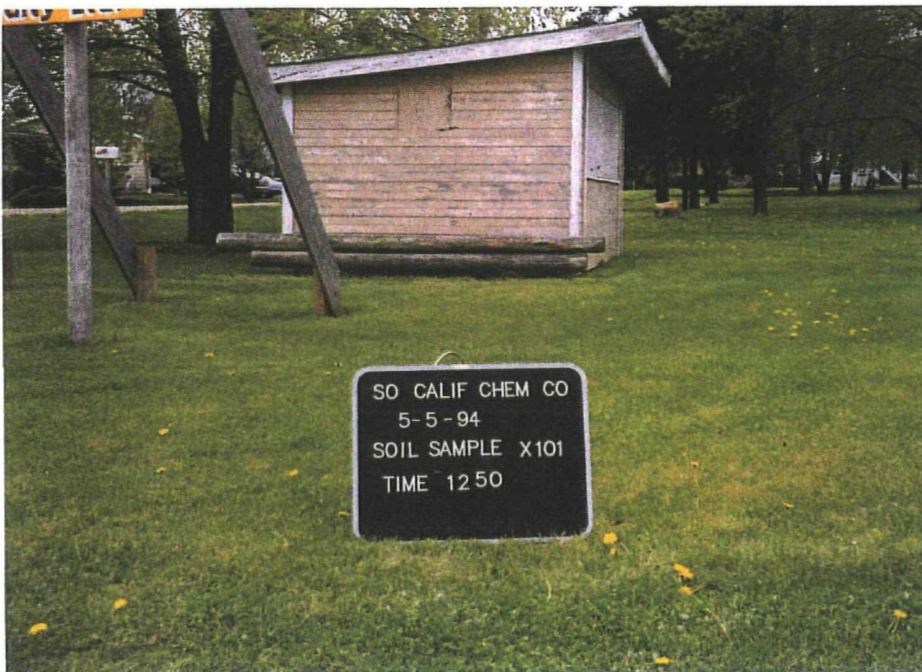
PICTURE TAKEN TOWARD
the south.

Background sample X101
collected at Union Park,
located approximately
3,000 feet northwest of
the site.

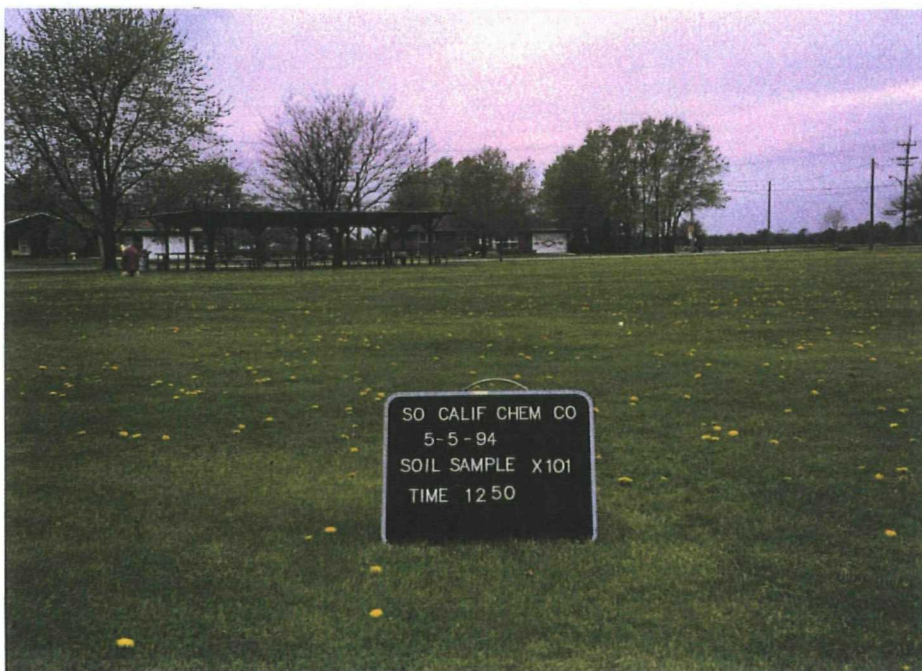
PICTURE TAKEN TOWARD
the west.

Sample X101 was collected
at a depth of 6 to 12
inches.
